# VALVES AND VALVE PROBLEMS

**MR. A. PERKINS (MSFC)**

## VALVES AND VALVE PROBLEMS

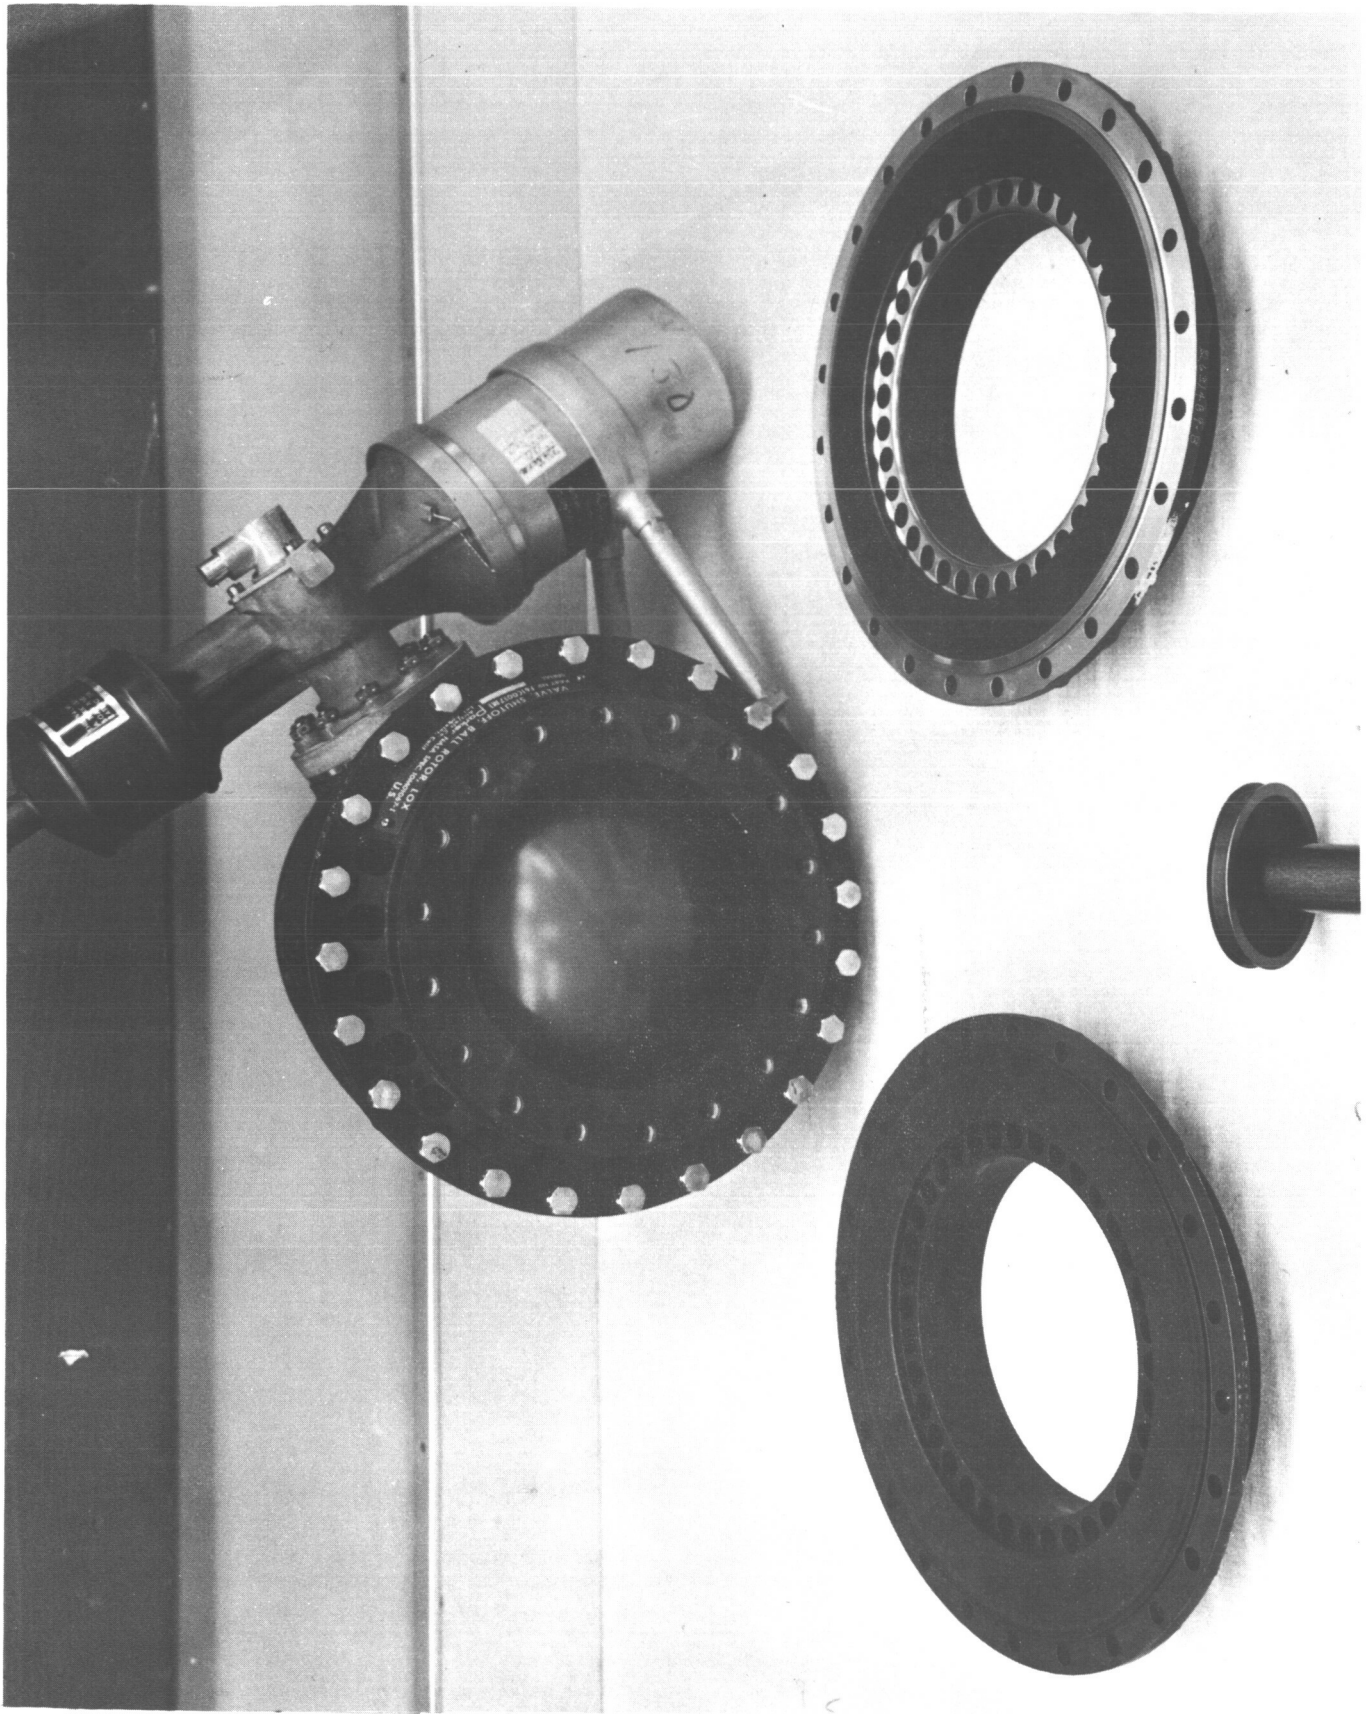
FIGURE 14. LOX CONTAINER FILL AND DRAIN VALVE

On the Block II Saturn Vehicles the same type valves are used as Pre-Valves in the engine feed lines and as container fill and drain valves in both the LOX and fuel systems. The only difference between the LOX and Fuel valves is a slight modification in the LOX valve so that it will operate in cold temperatures (Figure 14).

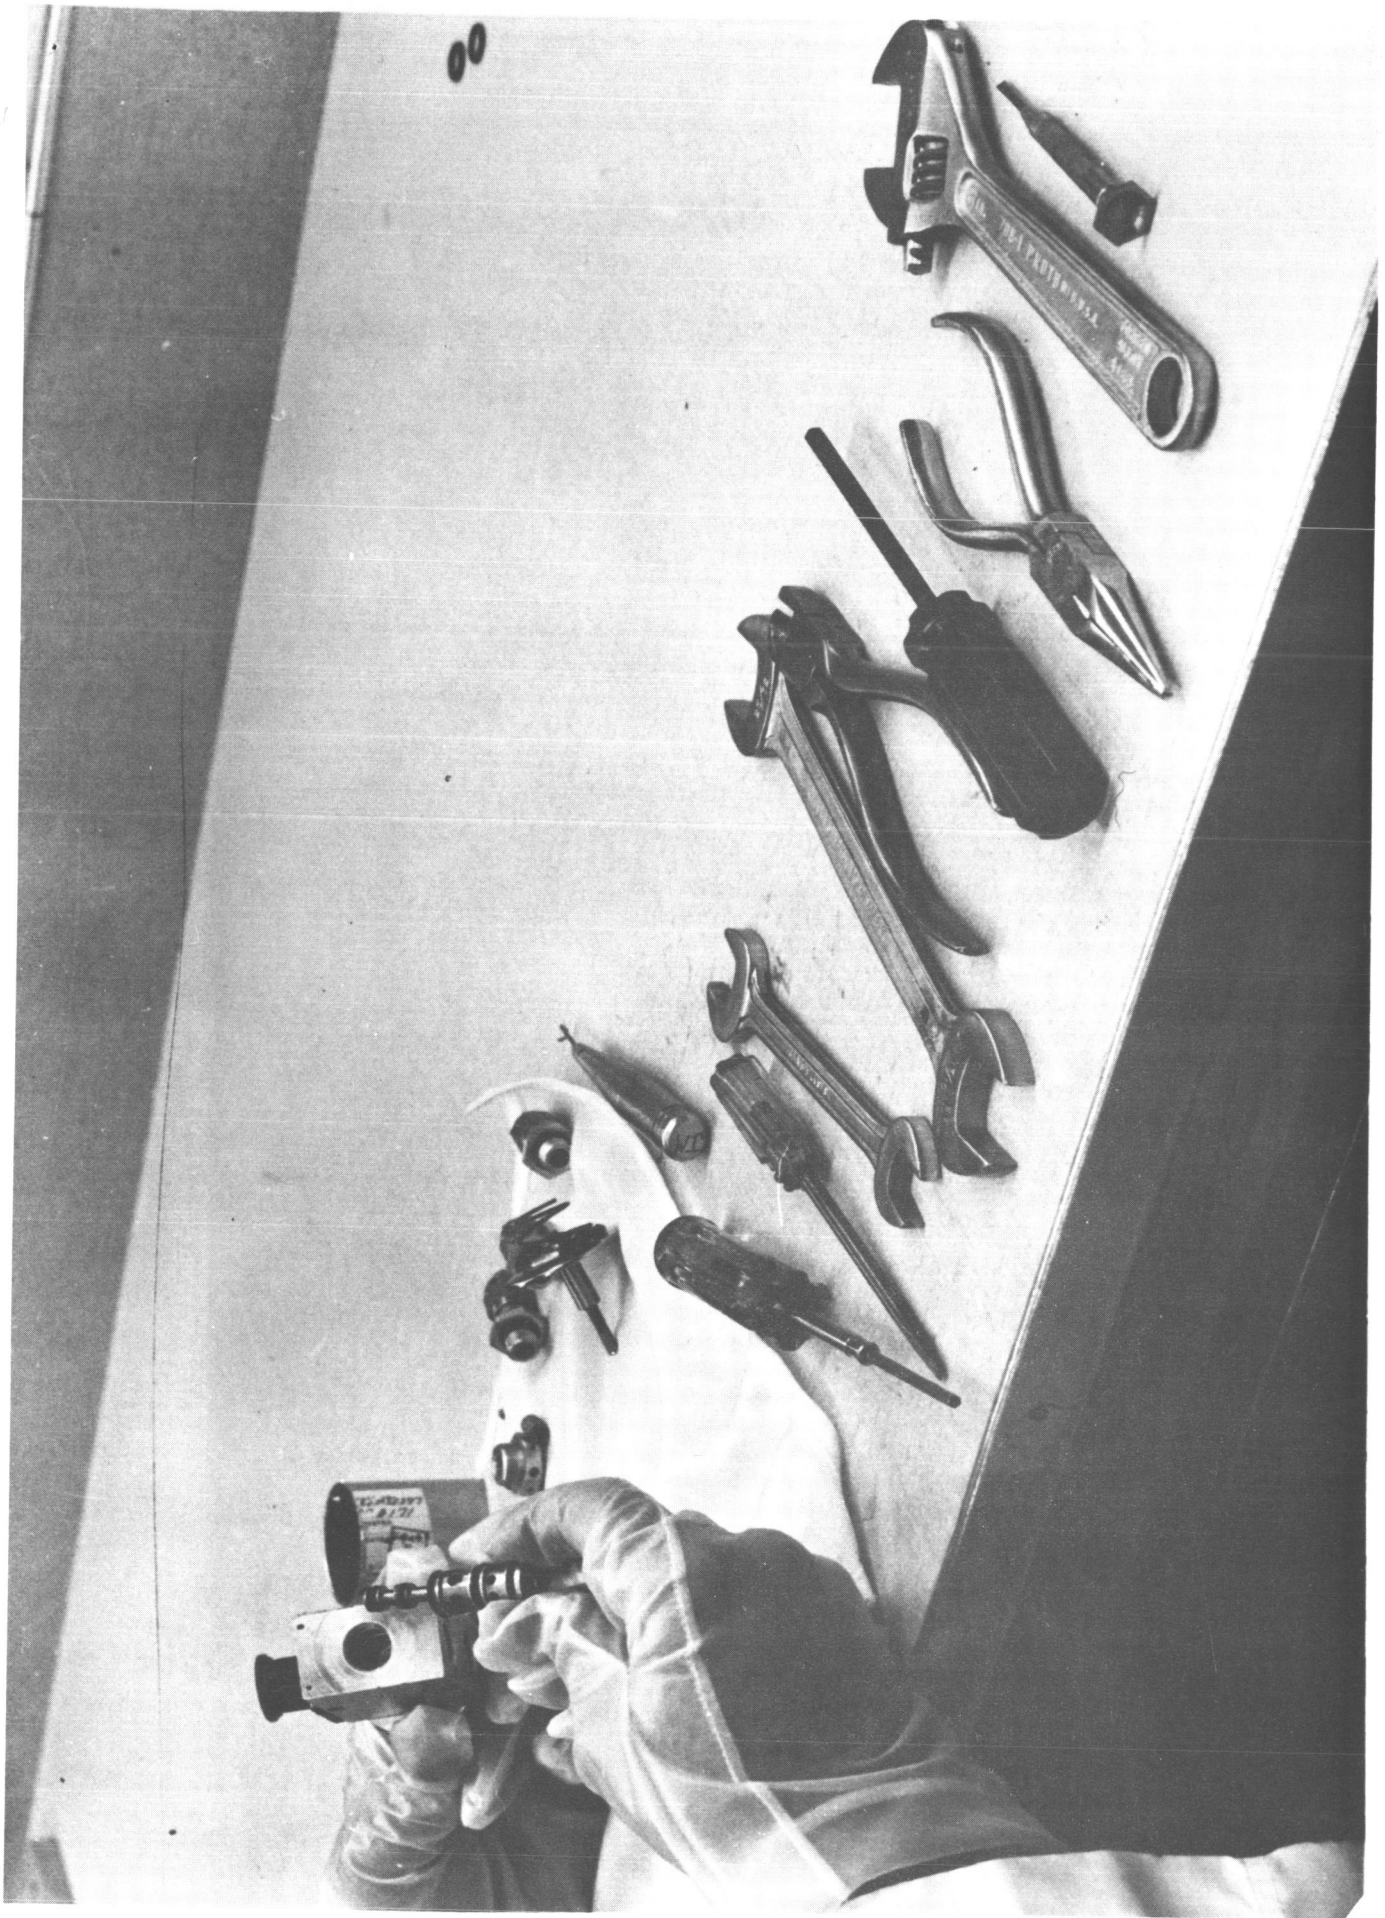
FIGURE 23. ASSEMBLY OF SOLENOID VALVES

Figure 23 shows the assembly of some of the many solenoid valves used in the pneumatic measuring and control systems of the Saturn Vehicle.

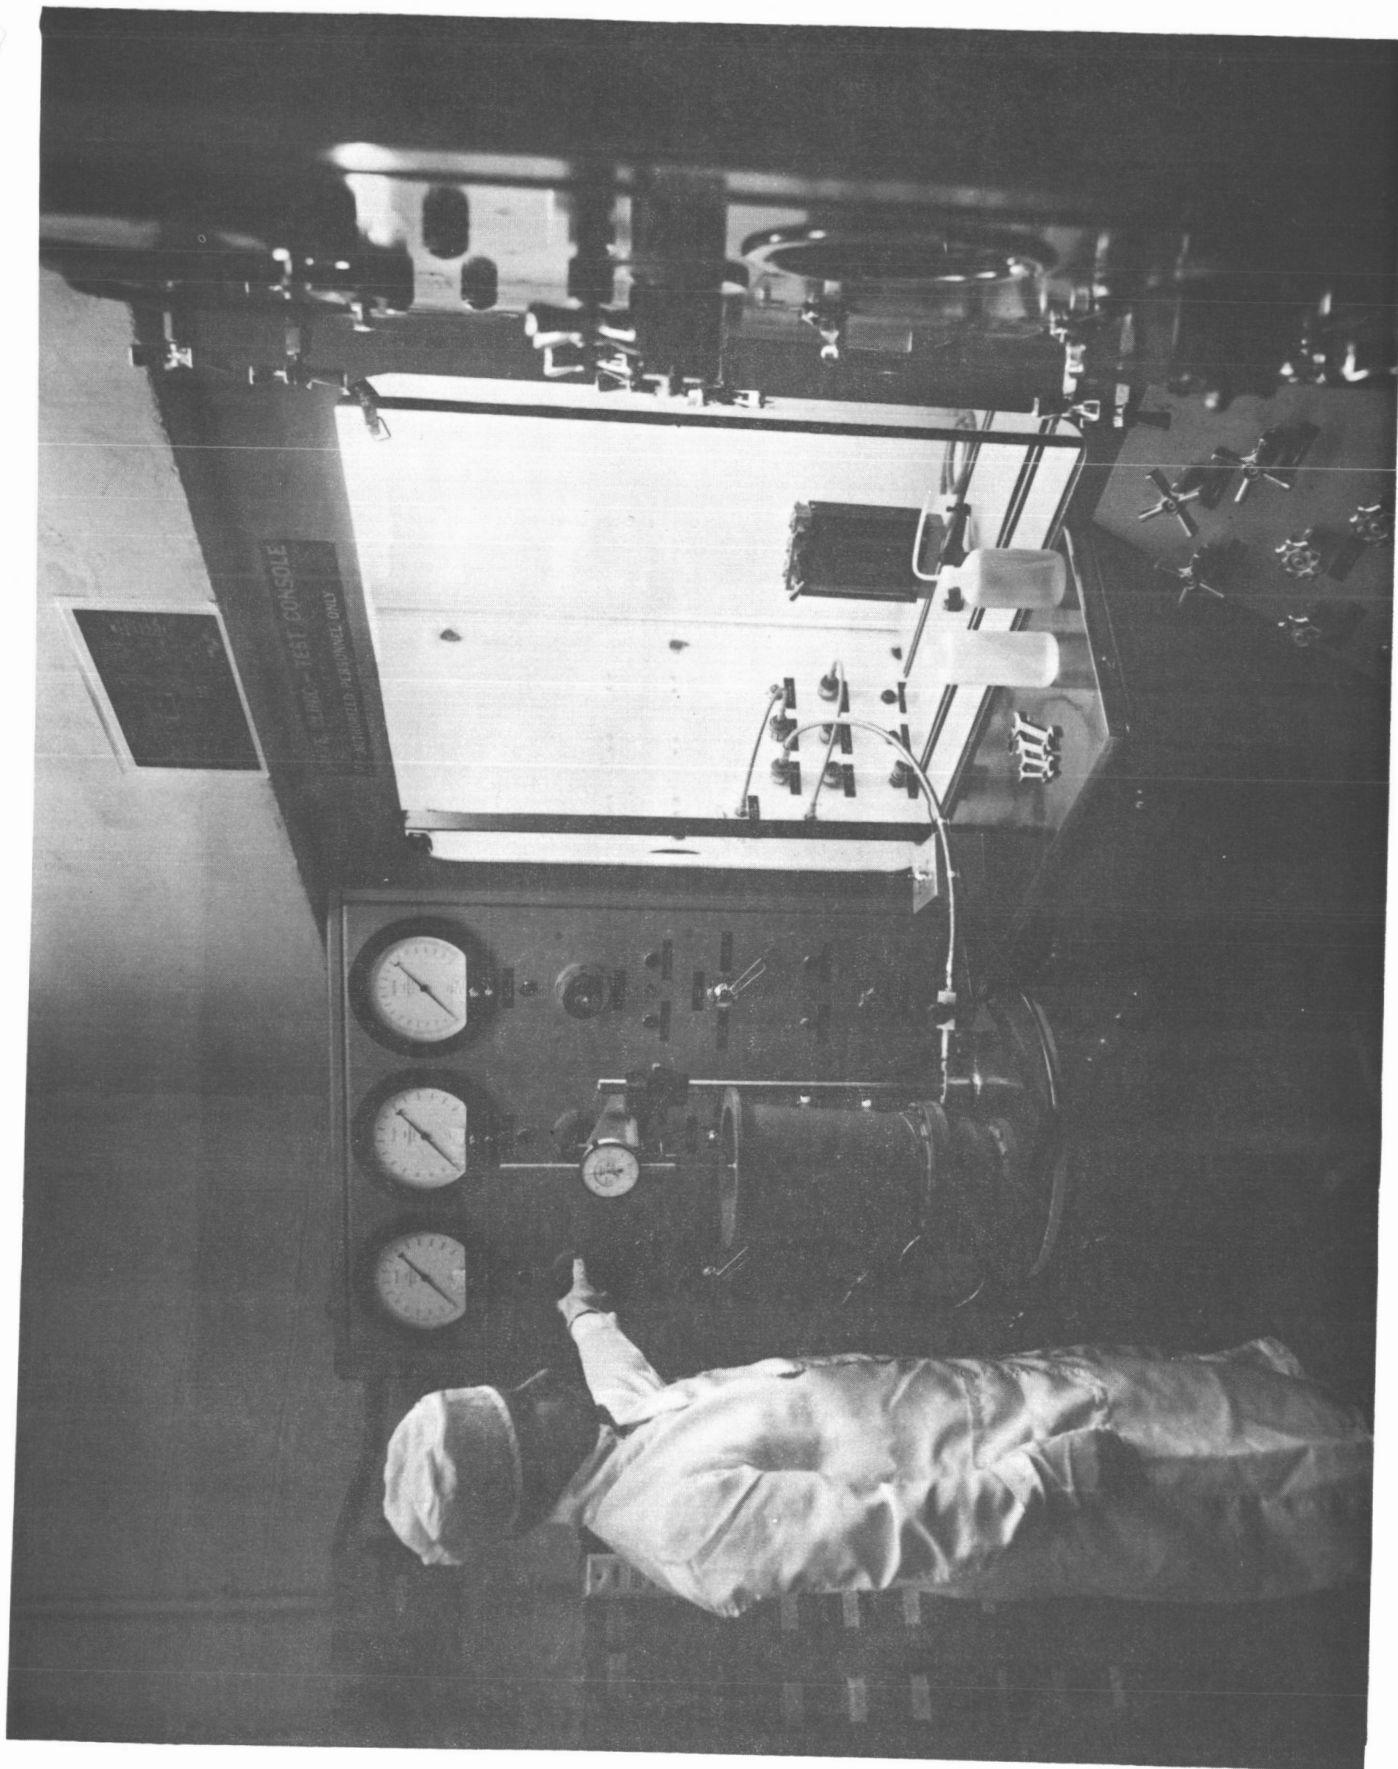
FIGURE 24. CHECKING THE OPERATION OF A LOX RELIEF VALVE ON THE PNEUMATIC TEST CONSOLE

Figure 24 shows a technician checking the operation of a LOX Relief Valve on the Pneumatic Test Console.

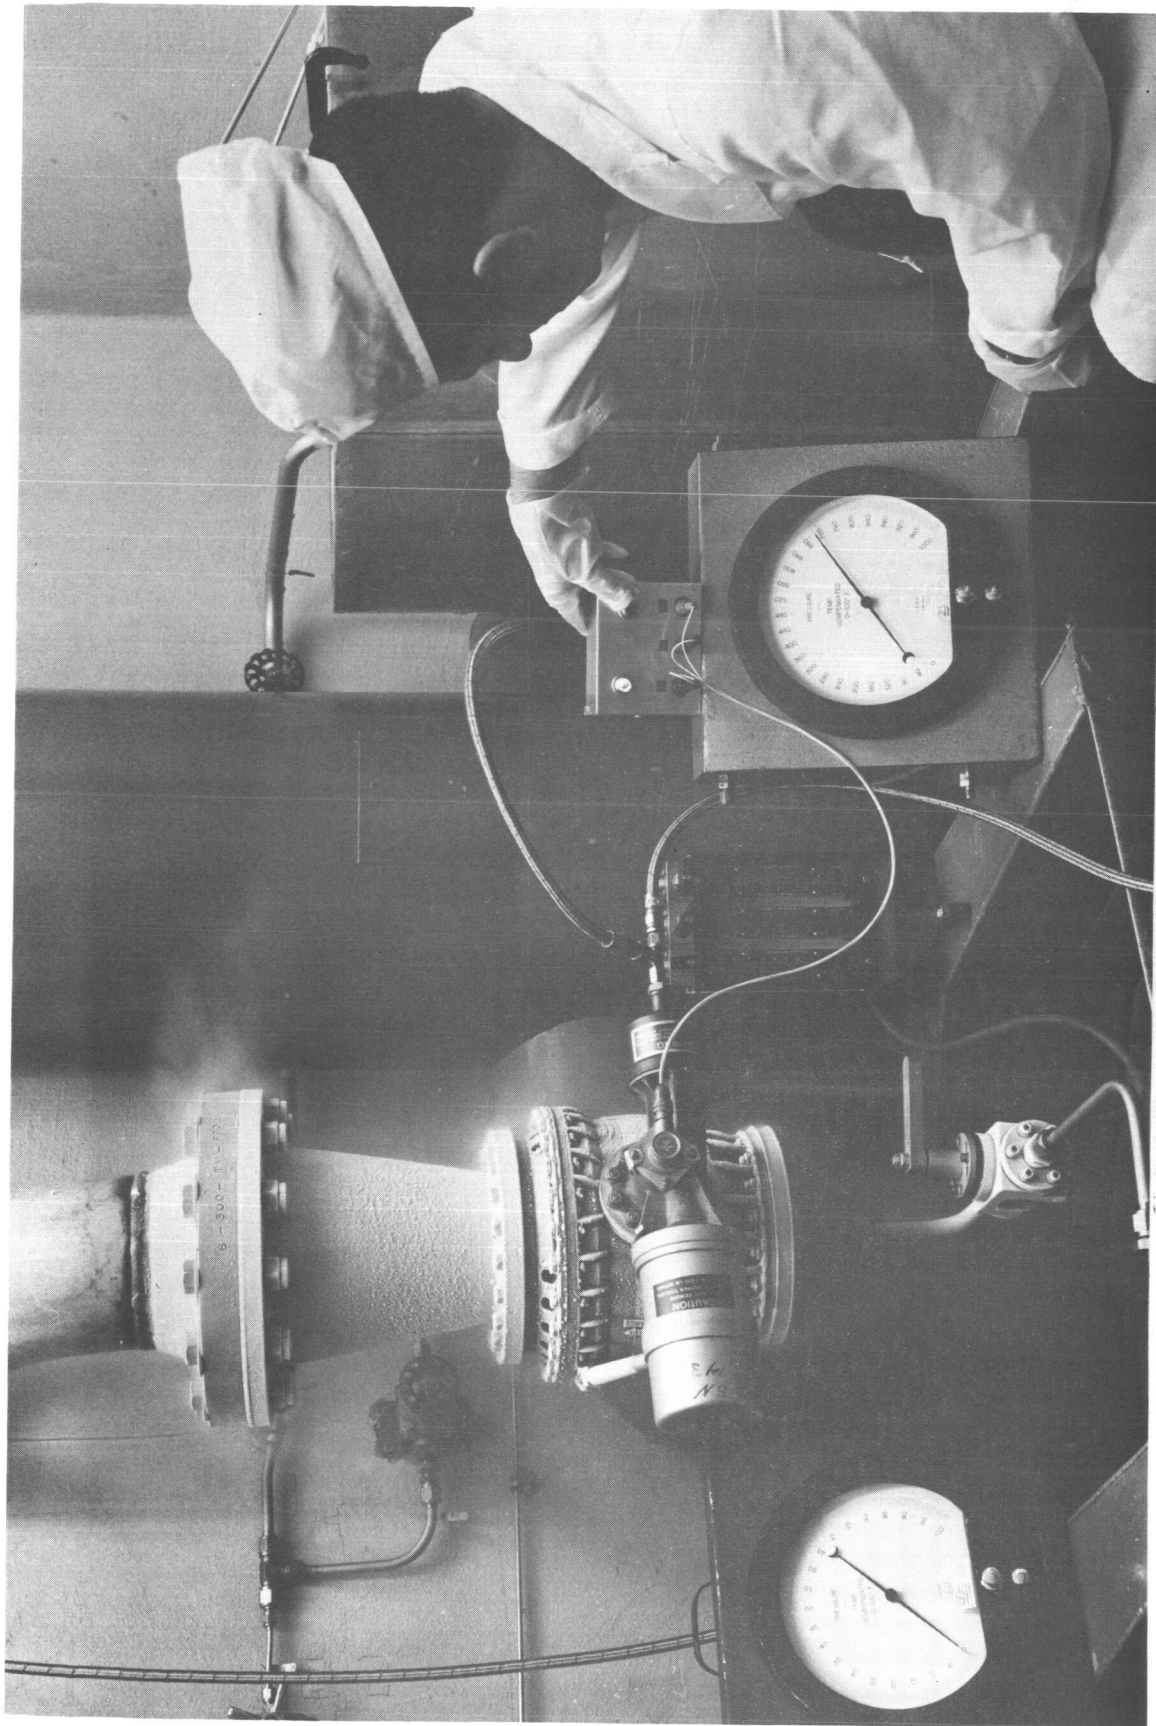
FIGURE 25. CHECKING THE OPERATION OF THE LOX PREVALVE UNDER COLD TEST CONDITIONS

Figure 25 shows a technician checking the operation of the LOX Pre-Valve under cold test conditions.

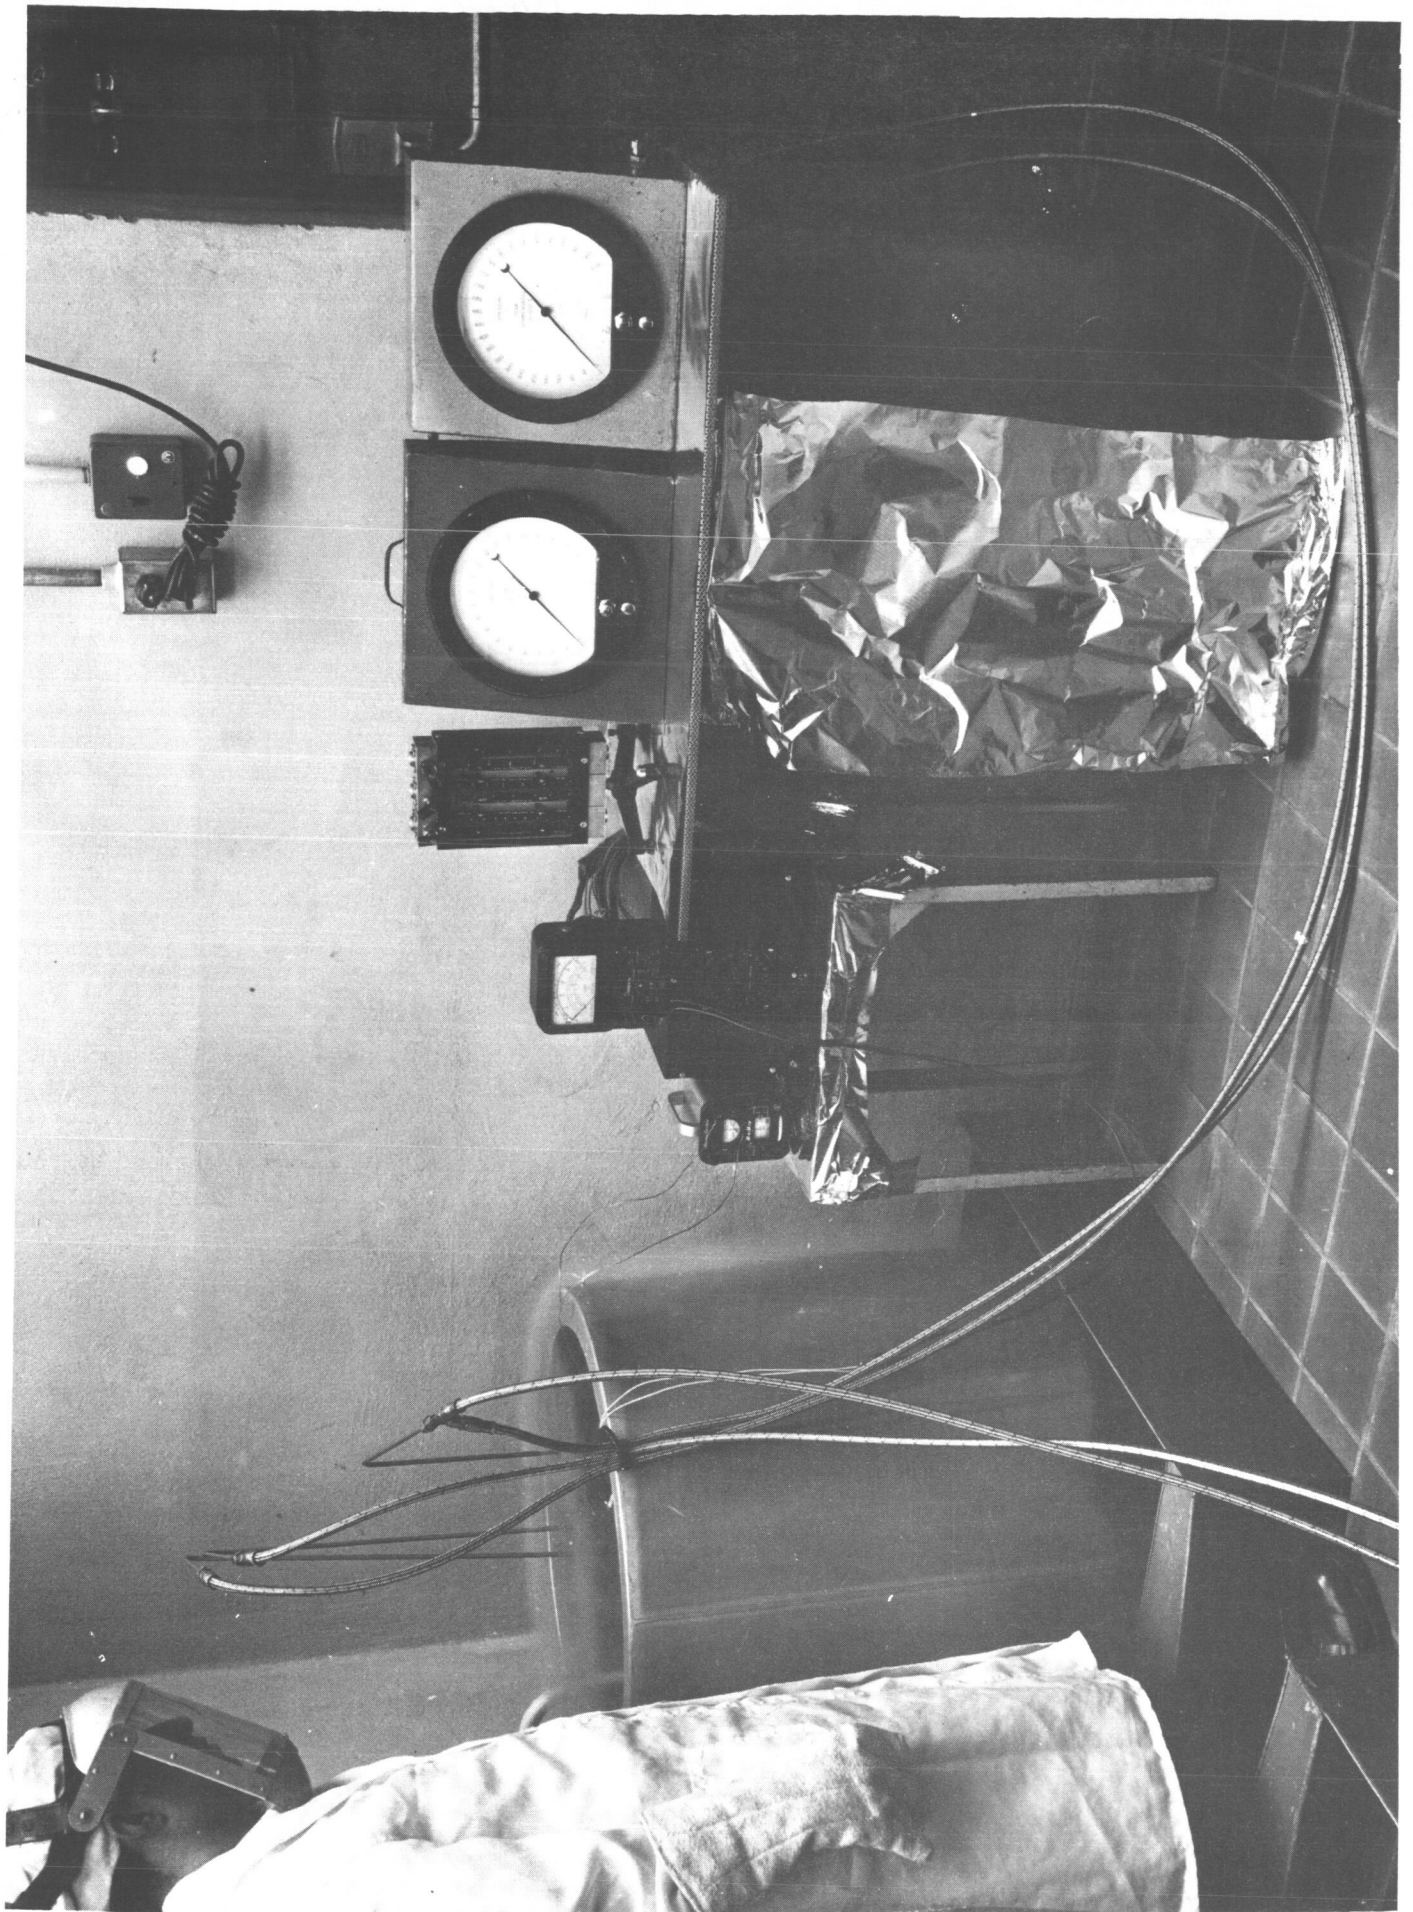
FIGURE 26. COLD TESTING OF A LOX RELIEF VALVE

Figure 26 shows the cold testing of a LOX Relief Valve.
